RON HOUGH
JOE MATTHEWS TERRY MURPHY
Inspecting Your Homes Since 1985

DATE: September 1, 2017

PROPERTY ADDRESS: 6625 Bobwhite Lane Browns Summit

SUMMARY/AREAS REQUIRING FURTHER EVALUATION

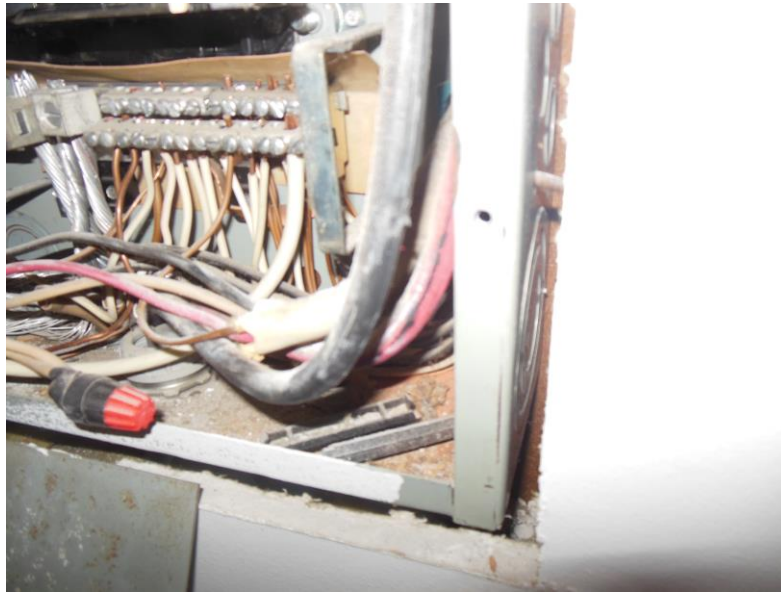
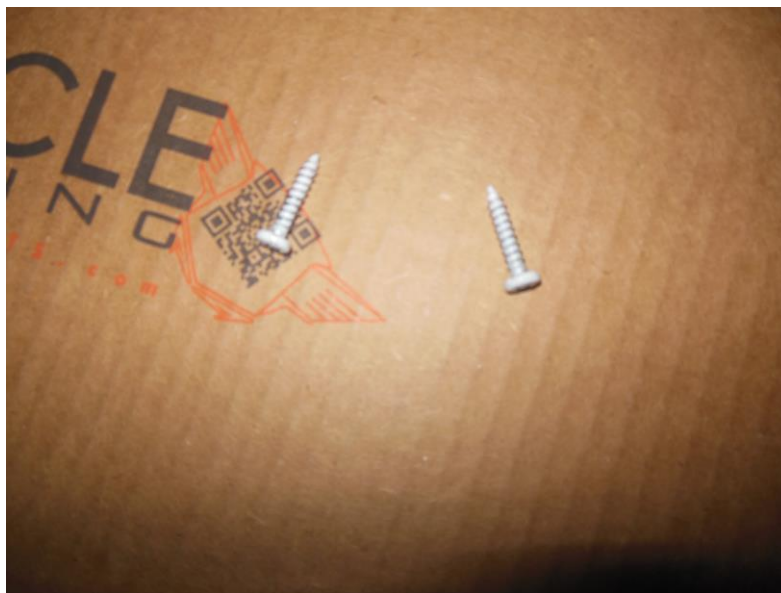
1. In the service panel the GFCI circuit breaker was off and was not tested.
2. It was noted that the service panel is located in a bedroom clothes closet which is typically not acceptable.
3. It was noted that the service panel cover is improperly installed with sharp screws which are cutting into the insulation on the wires improperly installed directly behind the panel cover screw holes.

A licensed electrician needs to further evaluate the above noted items and take the necessary corrective action.

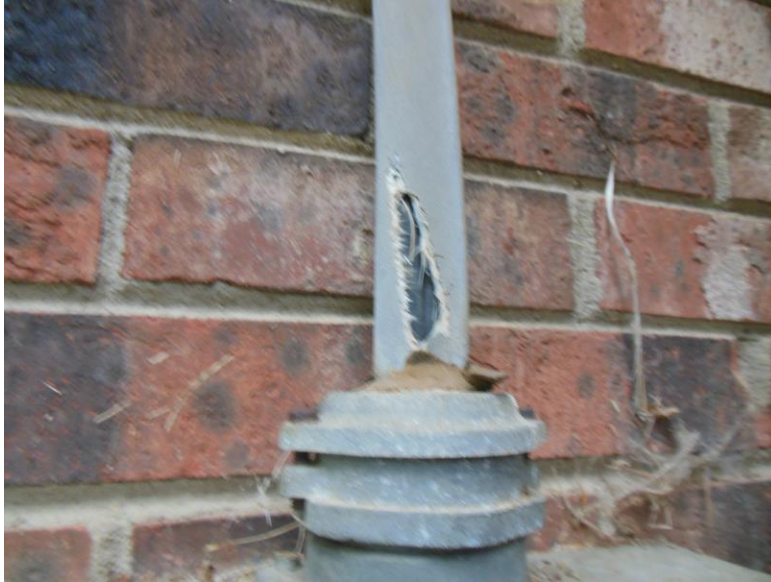
4. At the left side exterior of the home it was noted that a small section of the covering on the service entry wire is damaged.

4. At the left side exterior of the home it was noted that a small section of the covering on the service entry wire is damaged.
5. It appears that the electrical system may not be properly grounded and needs to be checked.

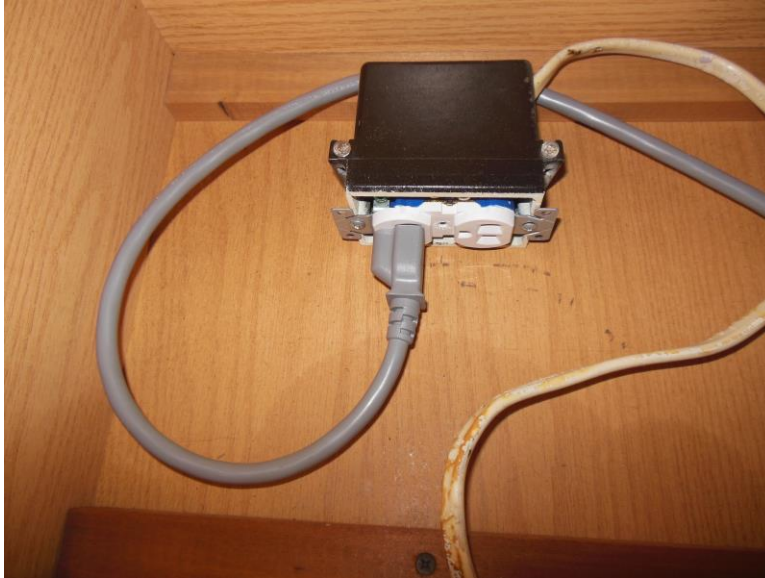
14. In the kitchen cabinet above the range a receptacle cover plate is missing.

9. In the kitchen cabinet above the range a receptacle cover plate is missing.
10. In the master bedroom closet the light cover is missing.
11. In the rear bedroom the light cover is missing.

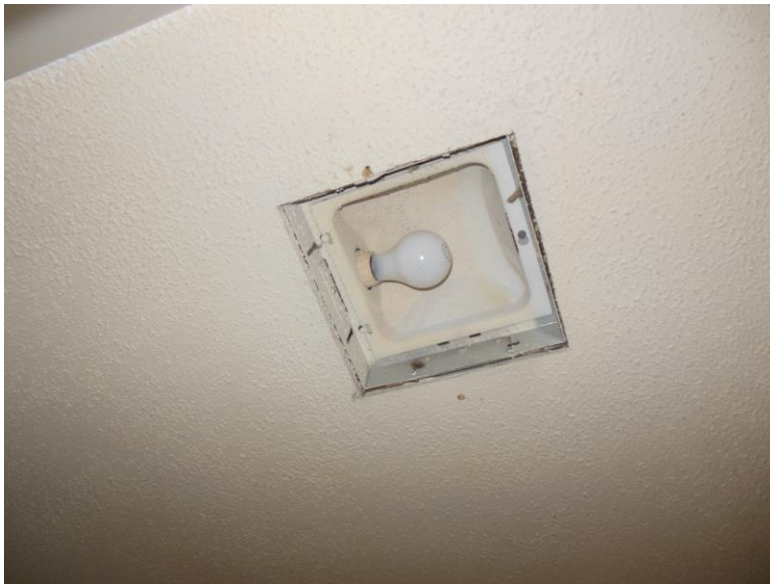
15. In the master bedroom closet the light cover is missing.

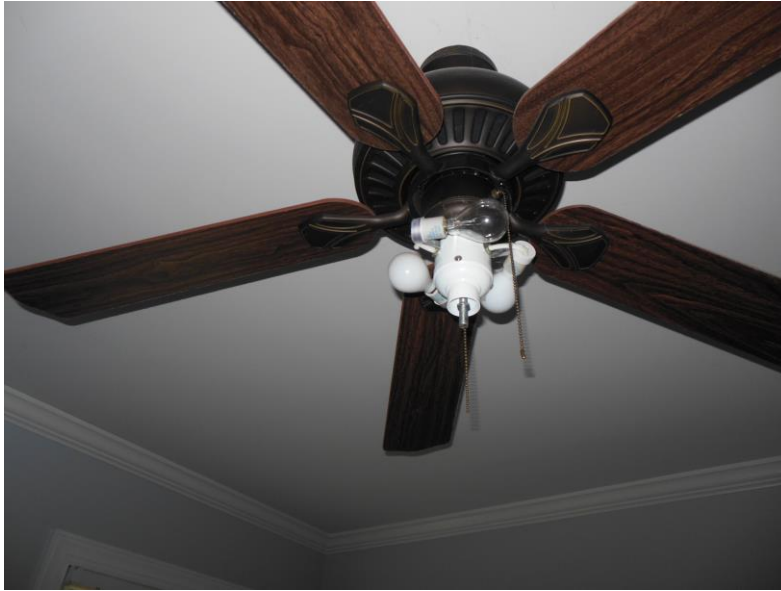
16. In the rear bedroom the light cover is missing.

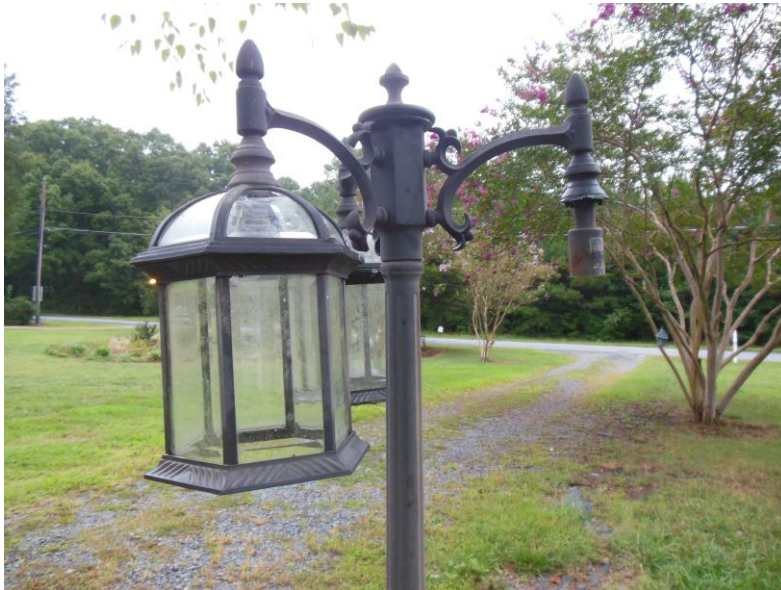
17. At the front exterior pole light the light cover is missing.

12. At the front exterior pole light the light cover is missing.
13. There are three prong ungrounded receptacles in the rear bedroom and in the rear family room. Three prong ungrounded receptacles are shock hazards.

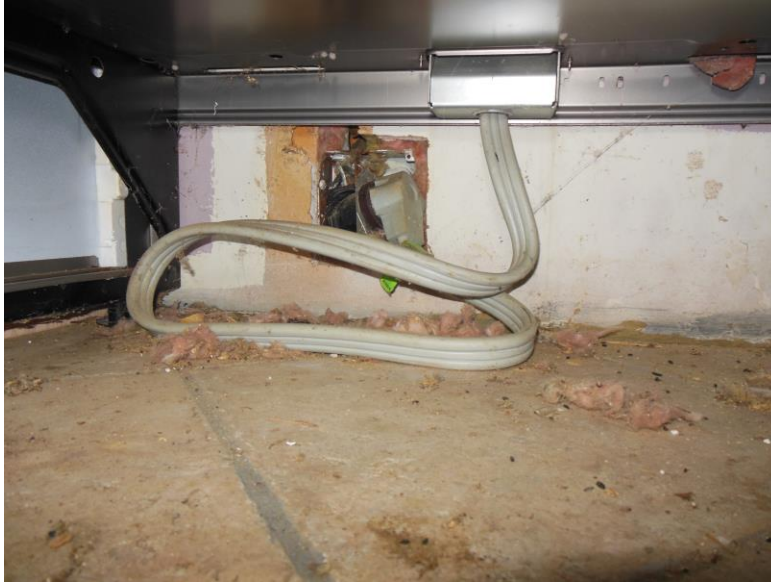
18. There are three prong ungrounded receptacles in the rear bedroom and in the rear family room. Three prong ungrounded receptacles are shock hazards.
19. In the kitchen the range receptacle is damaged and open and needs to be replaced.

14. In the kitchen the range receptacle is damaged and open and needs to be replaced.
15. In the laundry room the clothes dryer receptacle is loose and needs to be properly secured.

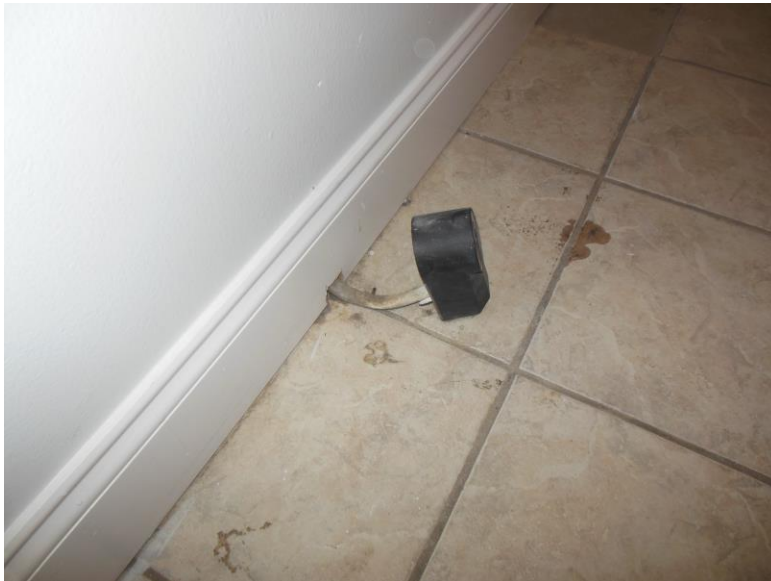
20. In the laundry room the clothes dryer receptacle is loose and needs to be properly secured.

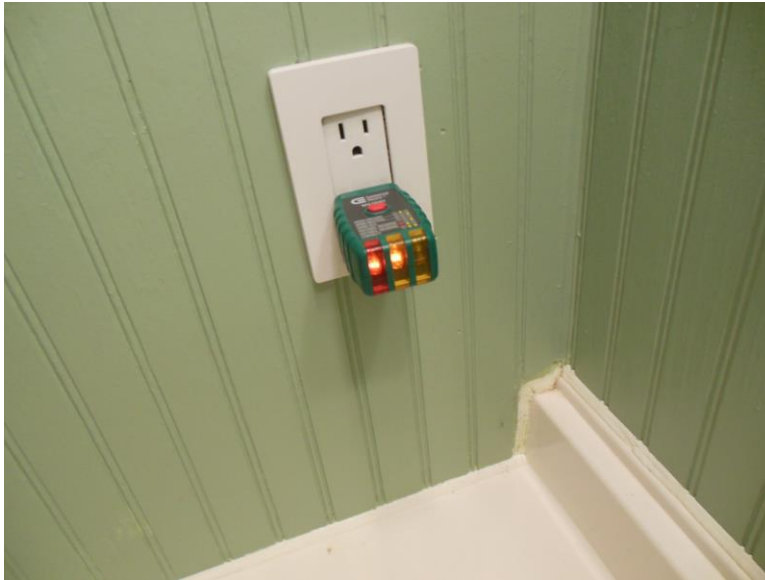
21. In the hall bathroom the receptacle is incorrectly wired with the hot and neutral wires reversed. This condition is a shock hazard.

16. In the hall bathroom the receptacle is incorrectly wired with the hot and neutral wires reversed. This condition is a shock hazard.
17. In the master bathroom it appears that the light fixture in the shower may not be a proper light fixture to be placed in a shower.

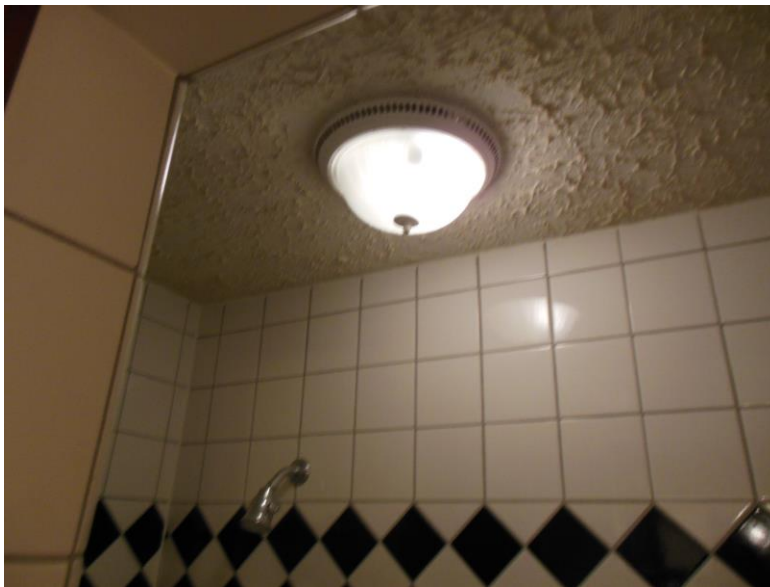
22. In the master bathroom it appears that the light fixture in the shower may not be a proper light fixture to be placed in a shower.

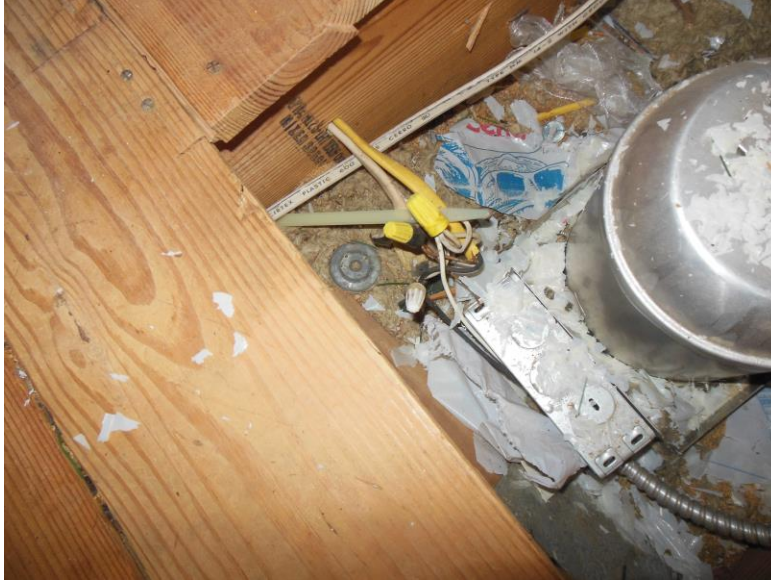
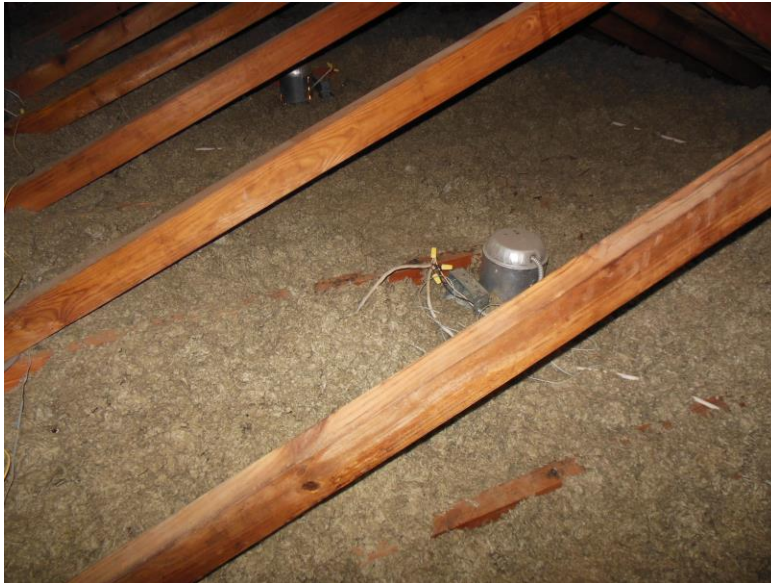
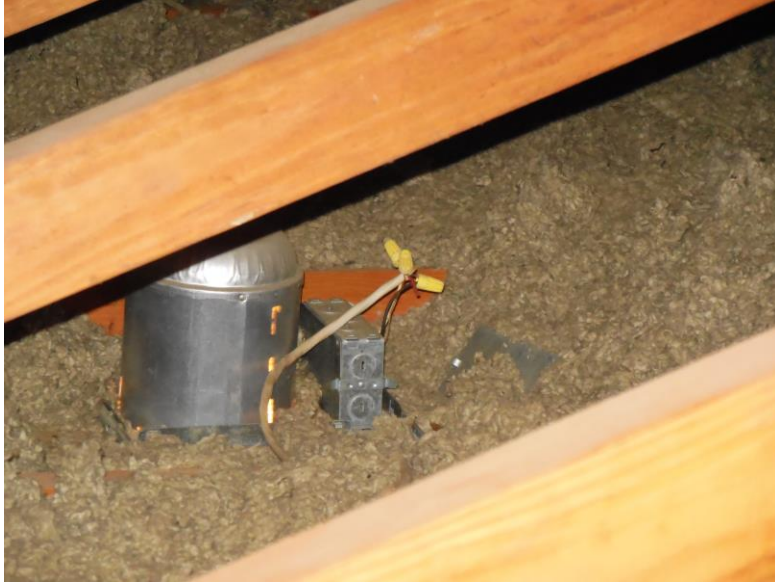
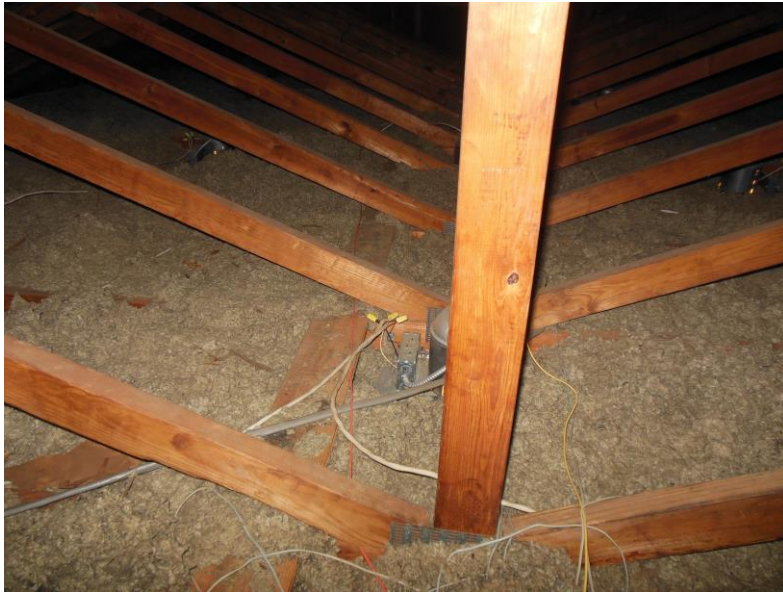
23. In the attic there are as many as fifteen open electrical cable splices that need to be placed in junction boxes. This condition is a shock and fire hazard.

18. In the attic there are as many as fifteen open electrical cable splices that need to be placed in junction boxes. This condition is a shock and fire hazard.

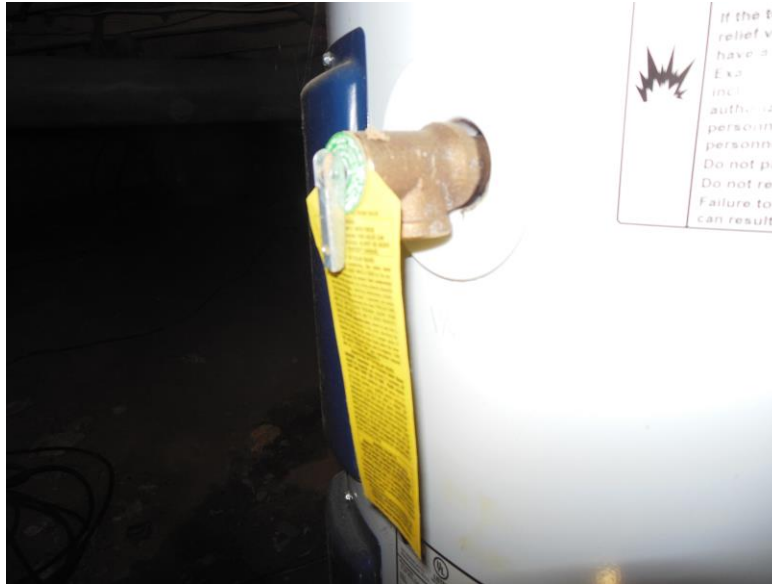
1. At the hot water tank the temperature/pressure relief valve should be piped to the ground so that the scalding hot water or steam is discharged harmlessly if the hot water tank malfunctions and the relief valve opens.

A licensed plumbing contractor needs to further evaluate the above noted items and take the necessary corrective action.

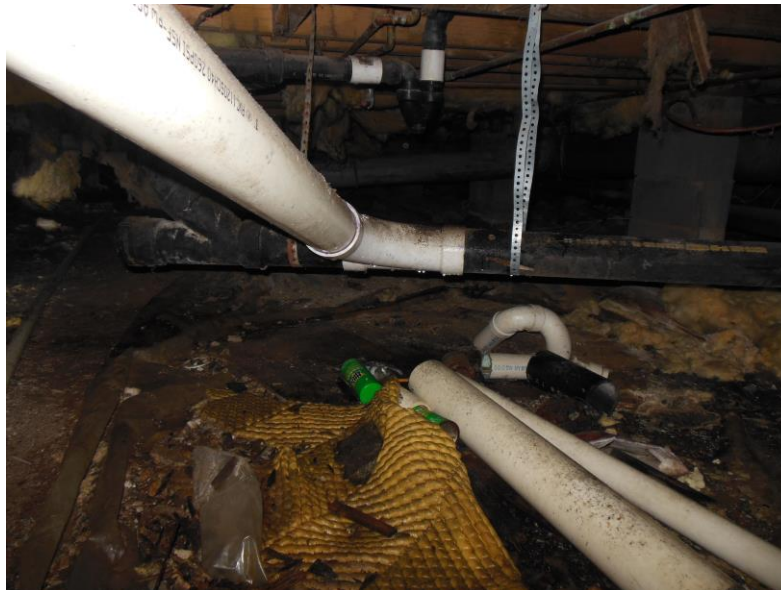
2. In the crawl space area under the bathrooms there are sections of white PVC plastic drain pipes improperly glued to sections of black ABS drain pipe.

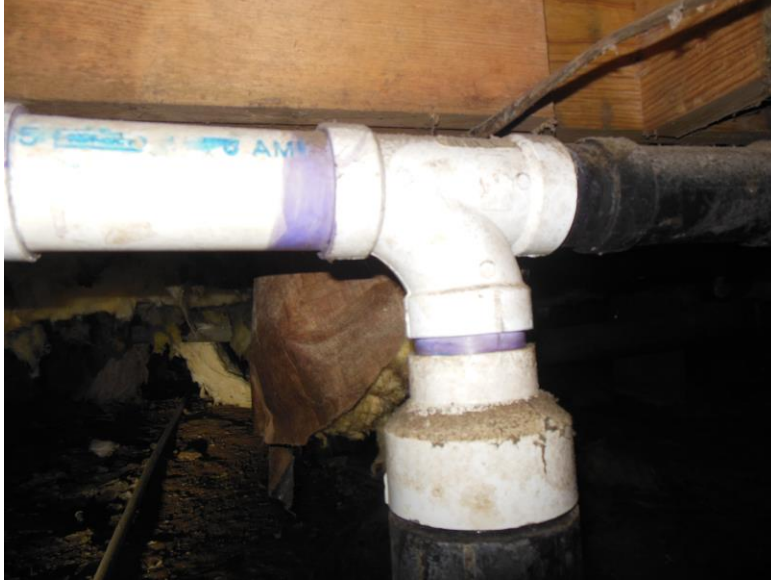
3. In the crawl space area under the bathrooms it appears that some of the drain pipes are improperly installed without correct connectors.

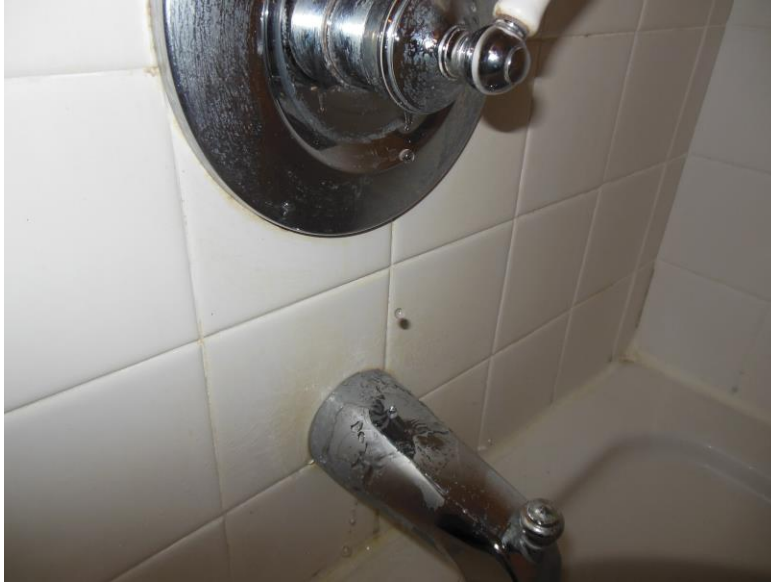
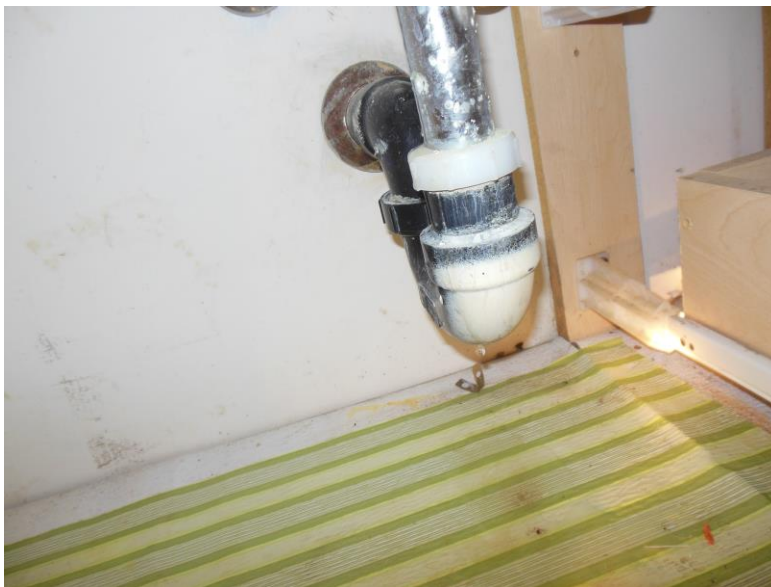
4. In the hall bathroom the bathtub faucet leaks at the handle, there is a leak at the drain pipe under the sink, the mechanical stopper at the bathtub did not work, and the operation of the whirlpool bathtub could not be tested.

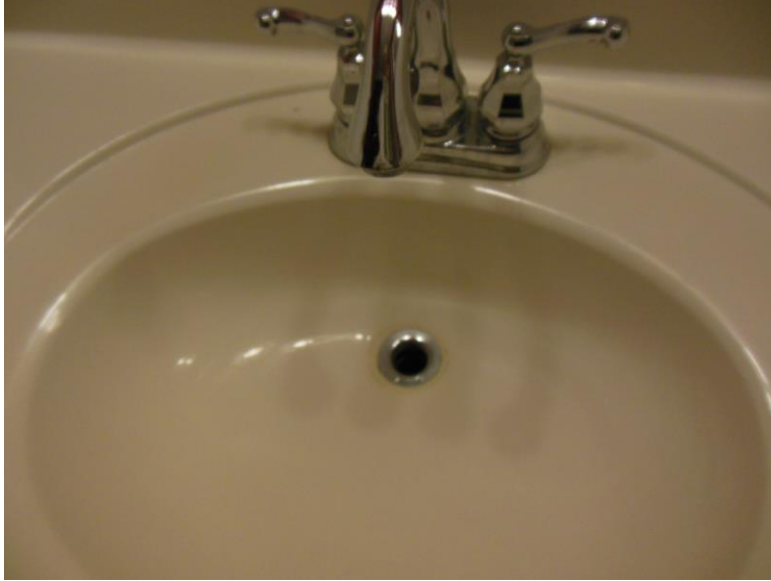
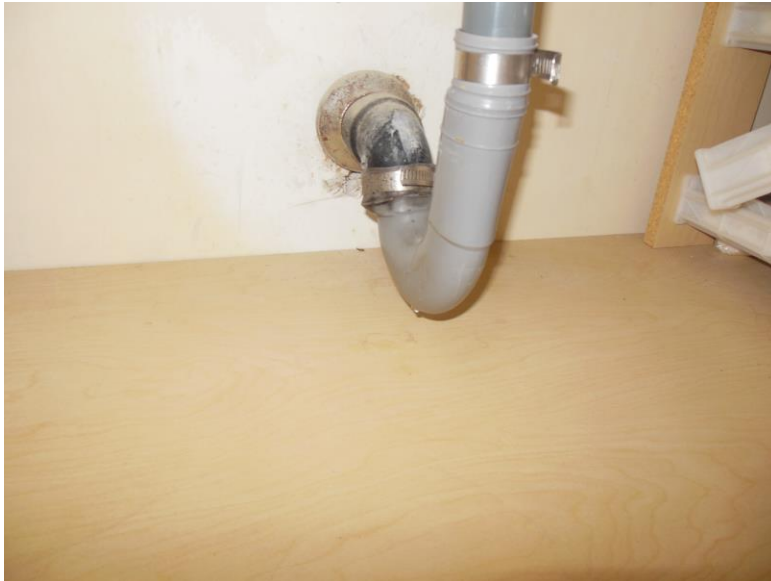
5. In the master bathroom one of the shower faucets did not work, there is a leak at the drain pipe under the sink, and the mechanical stopper for the sink is missing.

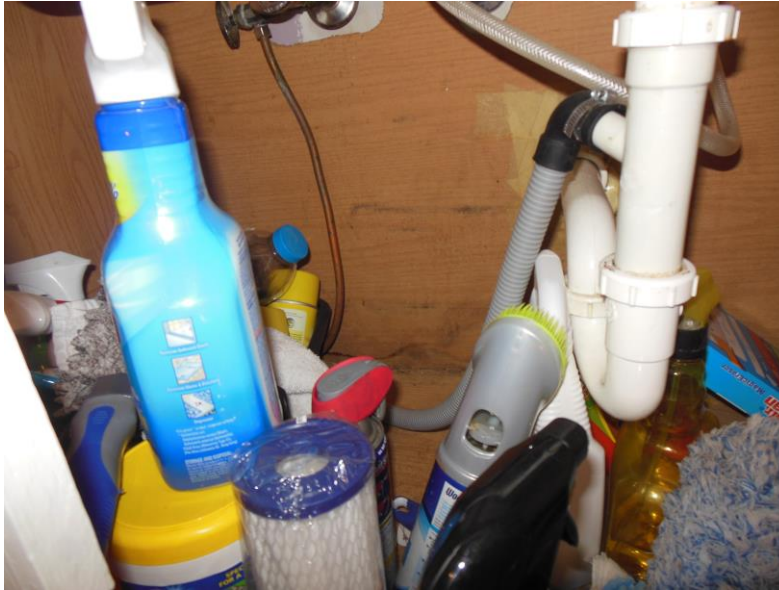
1. At the range the anti-tip bracket, which prevents the range from tipping over if a small child stands on the oven door, is not installed as required by the warning label and description on the oven door.
2. The dishwasher drain hose is improperly installed as the drain hose should have a high loop to a level above the sink drain. This condition may result in waste water unknowingly improperly draining back into the dishwasher.

An appliance repair contractor needs to further evaluate the above noted items and take the necessary corrective action.

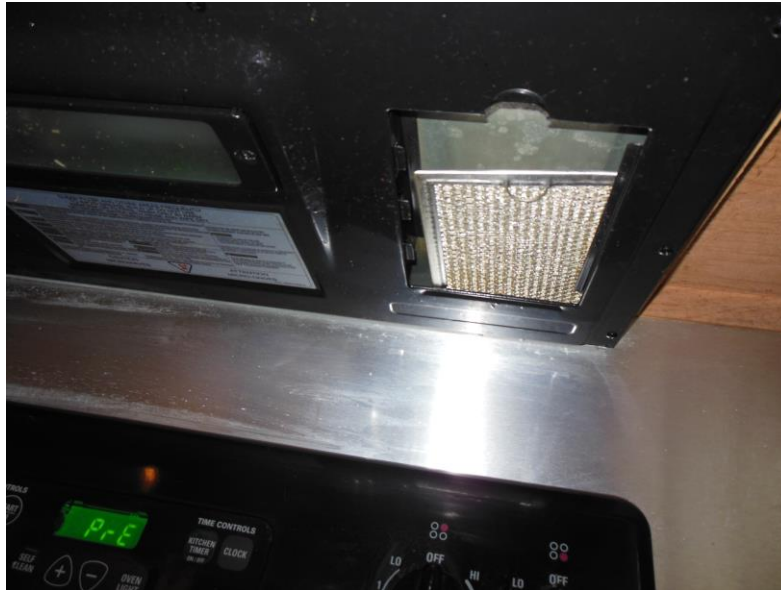
3. The oven light did not work.
4. At the range hood/microwave oven combination the fan filters are not properly installed.

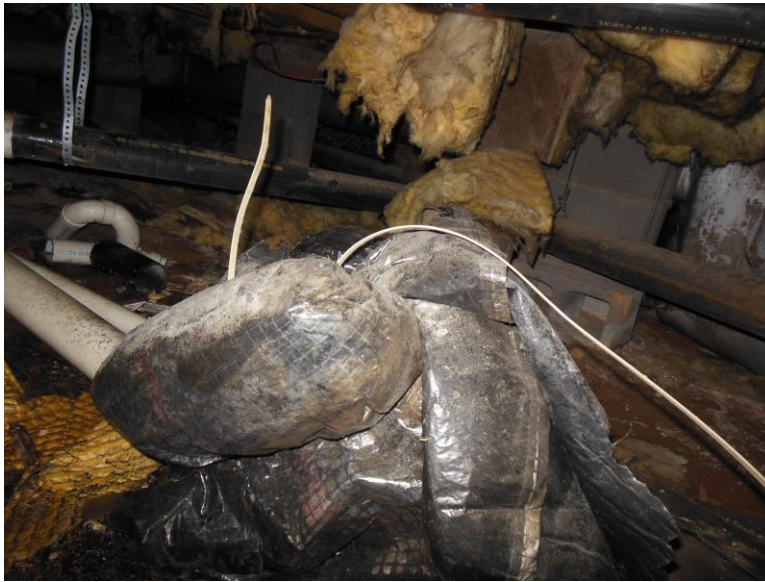
1. It was noted that there is no heat source for the rear family room.
2. It was noted that there is no installed cooling system for the rear addition.
3. It appears that the wall mounted electric heating units in the rear bedrooms are not properly sufficient.
4. In the crawl space area under the bathrooms one air supply duct appears to be improperly closed and covered.

A licensed mechanical contractor needs to further evaluate the above noted items and take the necessary corrective action.

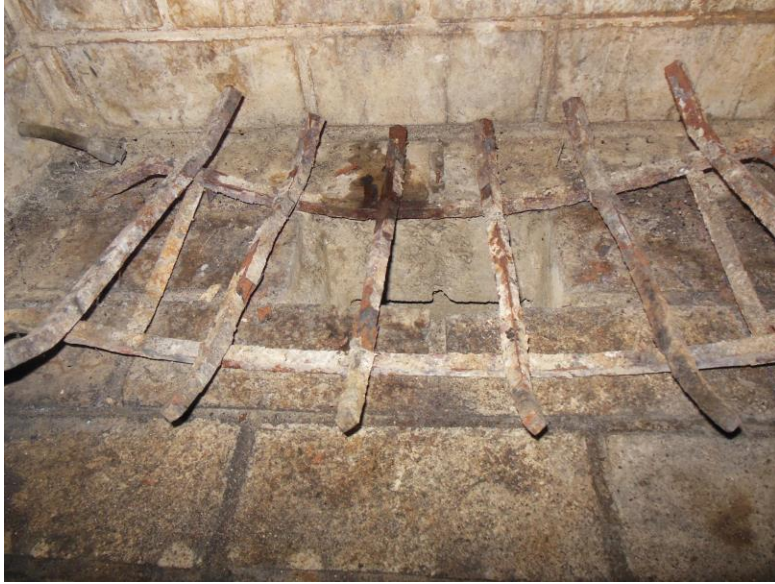
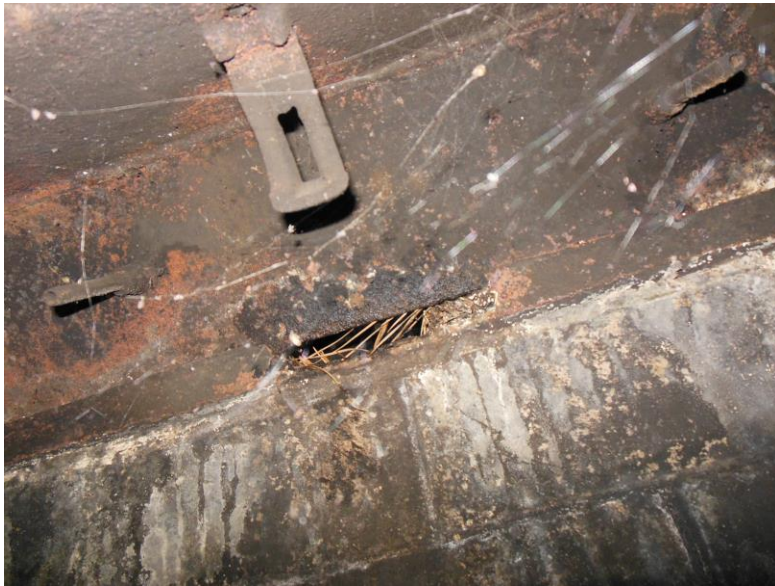
5. At the fireplace the ash dump door is missing and a section of the damper frame is damaged.

A chimney sweep needs to further evaluate the above noted items and take the necessary corrective action.

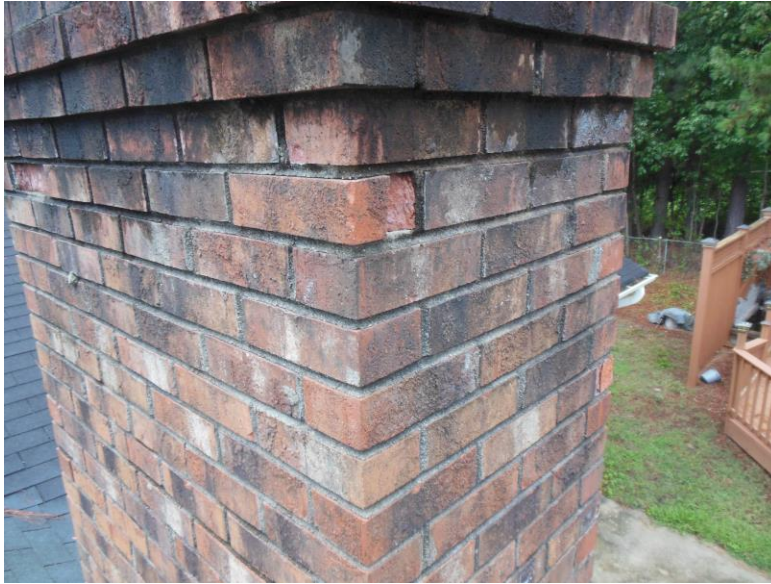
6. At the chimney some of the brickwork is spalling and damaged.

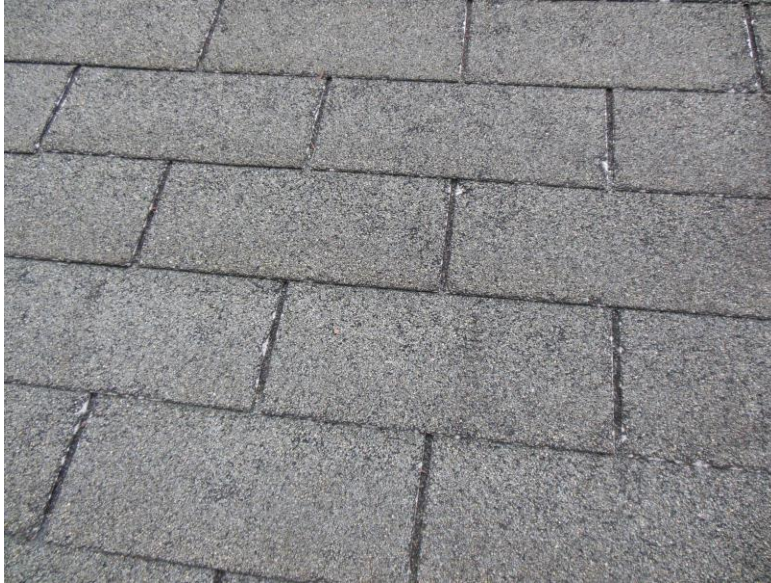
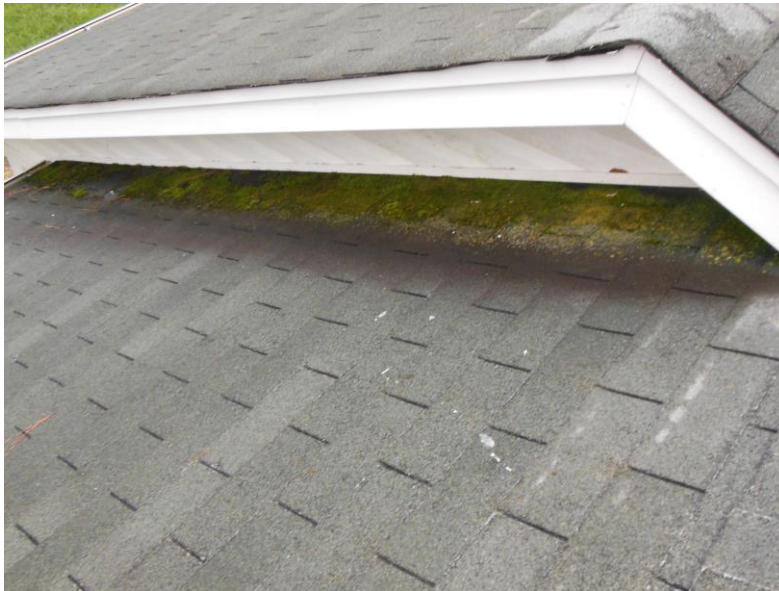
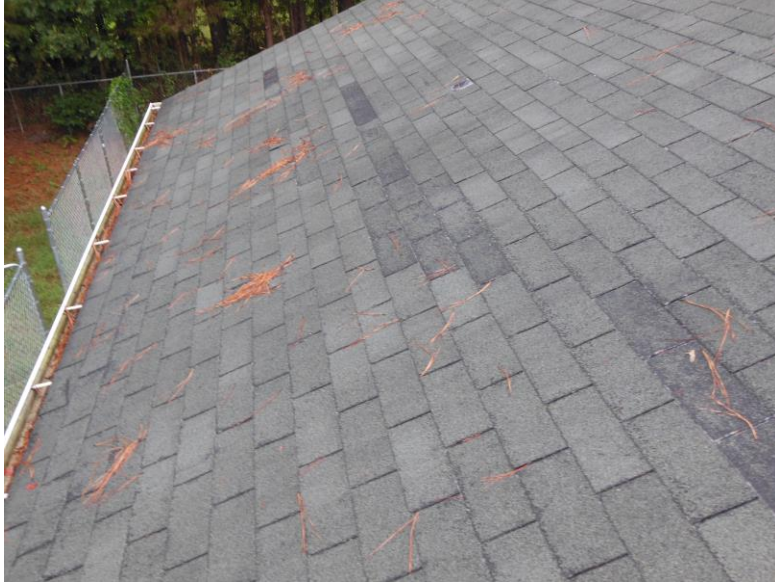
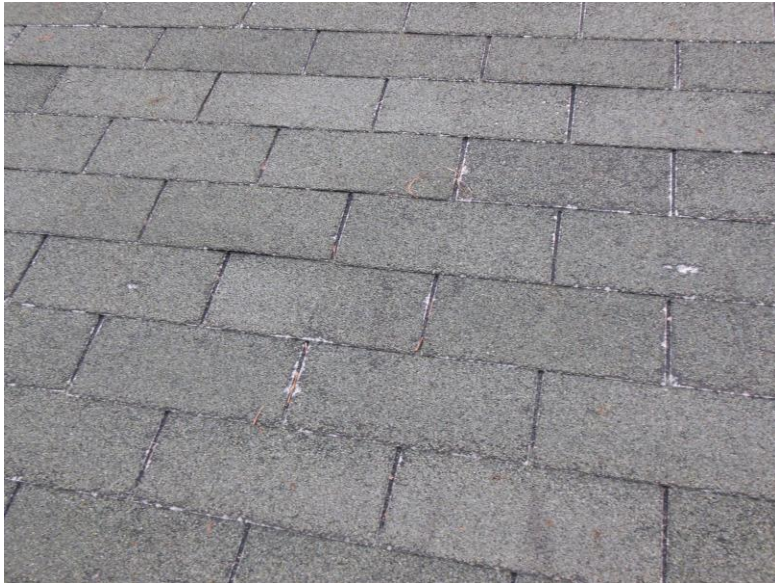
1. The roof shingles show signs of age with some moss growth on the roof shingles, a loss of adhesion, and deterioration along the edges of the roof shingles.

A roofing contractor needs to further evaluate the condition of the roof shingles, check the above noted items, and take the necessary corrective action.

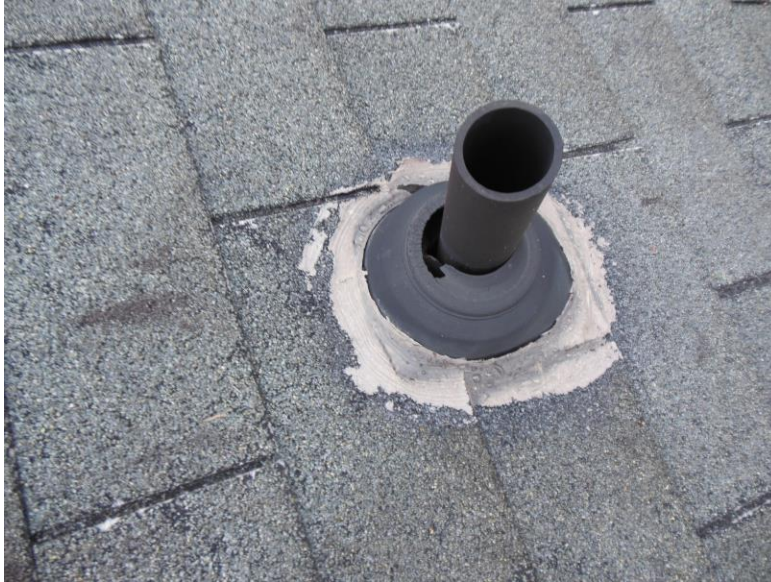
2. At the rear section of the roof the plumbing vent pipe flashing is damaged with an active roof leak.

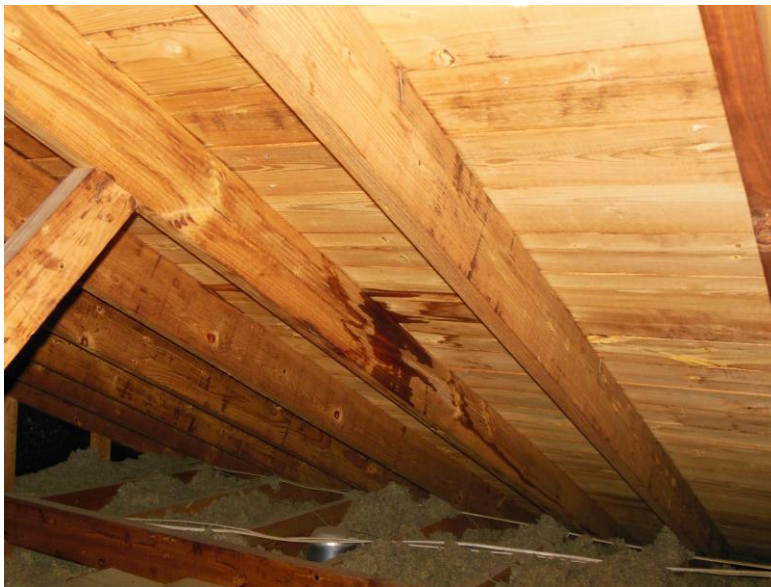
3. In the left rear section of the attic there is an active roof leak with water stained roof sheathing.

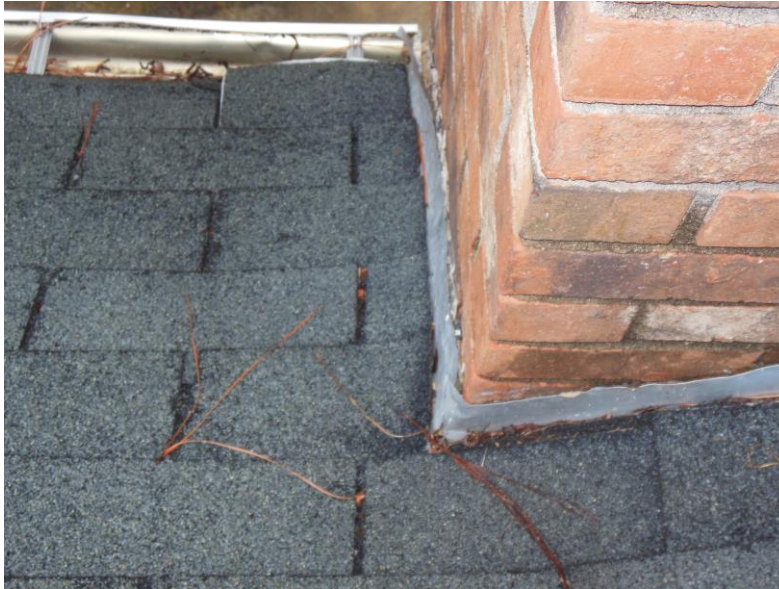
4. At the chimney some of the roof flashing is loose.

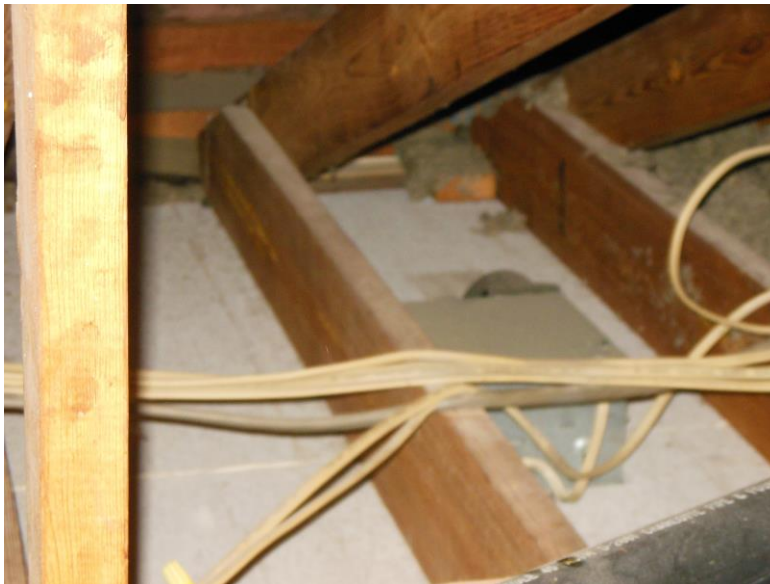
5. In the attic area above the master bathroom some of the insulation is missing and needs to be replaced.

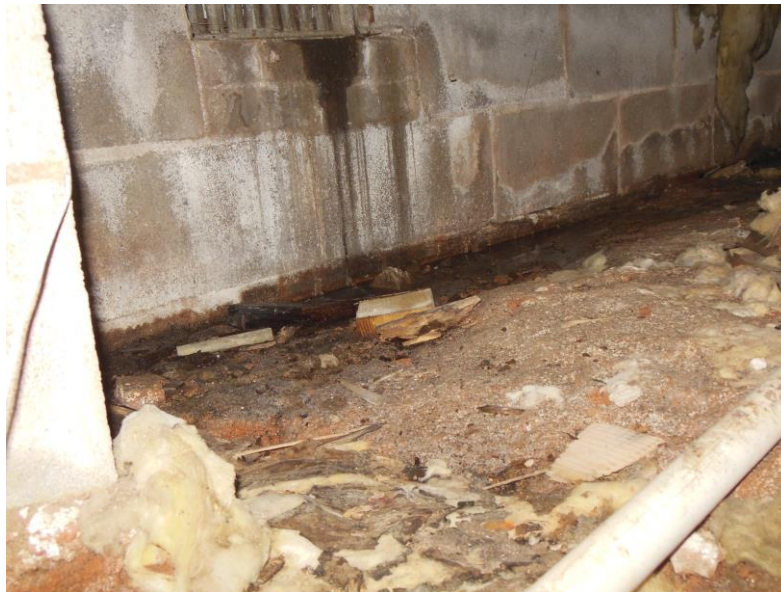
1. In the rear section of the crawl space there are signs of minor water penetration of the foundation wall with puddles of standing water. The crawl space area needs to stay relatively dry as high humidity levels may cause damage to the wood floor structure. Standing water may cause damage to the foundation walls and improper settlement of the foundation walls. The gutters need to be kept clean. The downspouts may need to be extended. The landscaped areas adjacent to the foundation walls need to be properly sloped downward away from the foundation walls. The crawl space area and the drainage of the downspouts need to be checked under heavy rain conditions to make sure that the rain water drains safely away from the foundation walls and that the crawl space stays relatively dry.

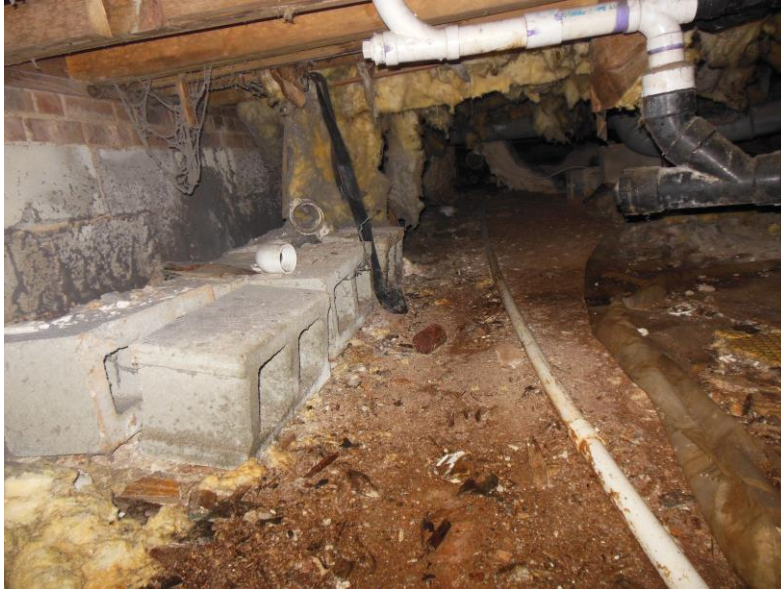
2. In the crawl space many sections of the floor insulation have fallen and/or are damaged and need to be replaced.

The above noted structural damage needs to be further evaluated and repaired as necessary by a licensed general contractor. It is suggested that any structural repairs be completed under the supervision of the local municipal building inspector and/or a licensed structural engineer.

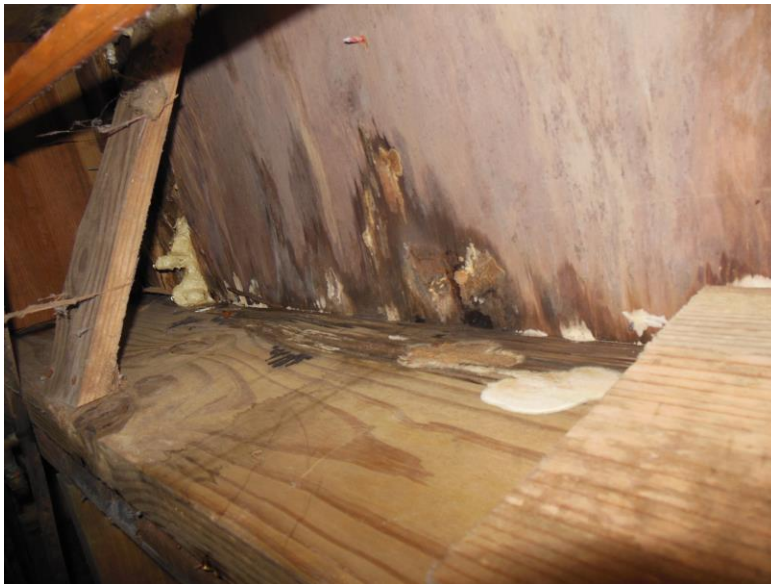
3. In the crawl space area under the bathrooms some of the floor framing has been water stained and damaged with some repairs that do not appear to be properly completed.

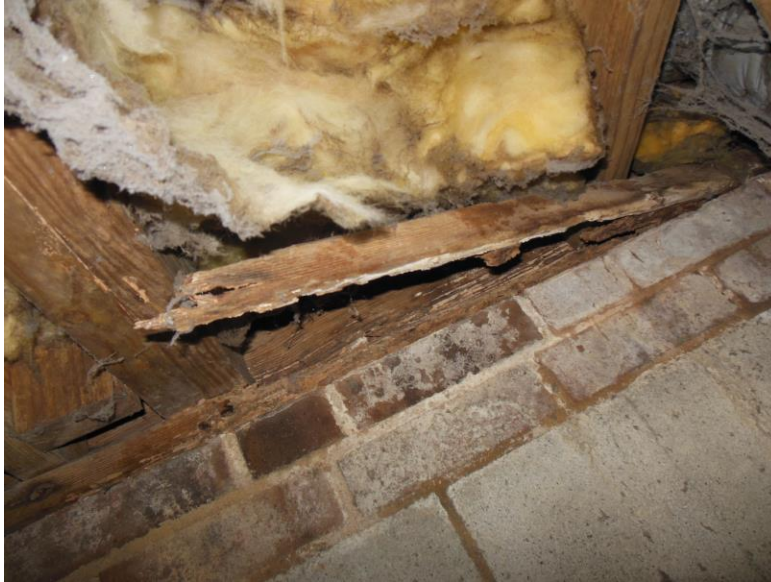
4. In the rear section of the crawl space a small section of the band and sill near the chimney are damaged.

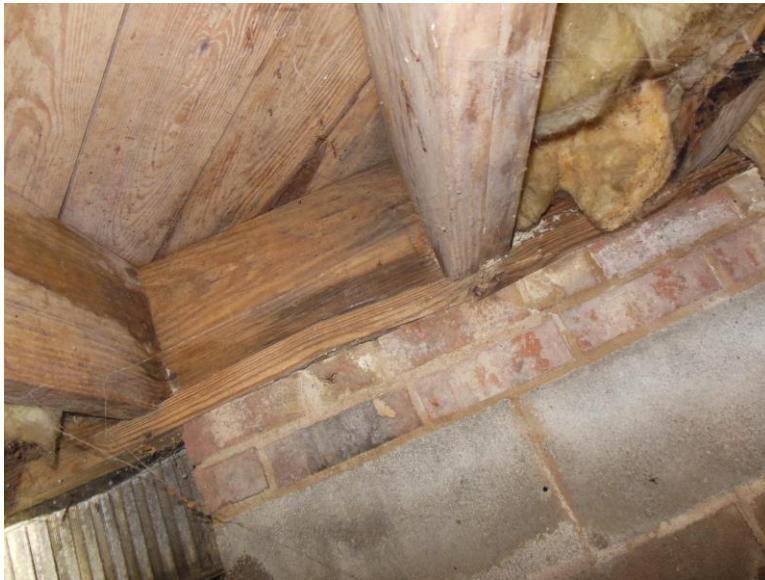
5. In the crawl space area under the rear exterior patio door section of the band, sections of the sill, and the ends of the floor joists are damaged and need to be repaired.

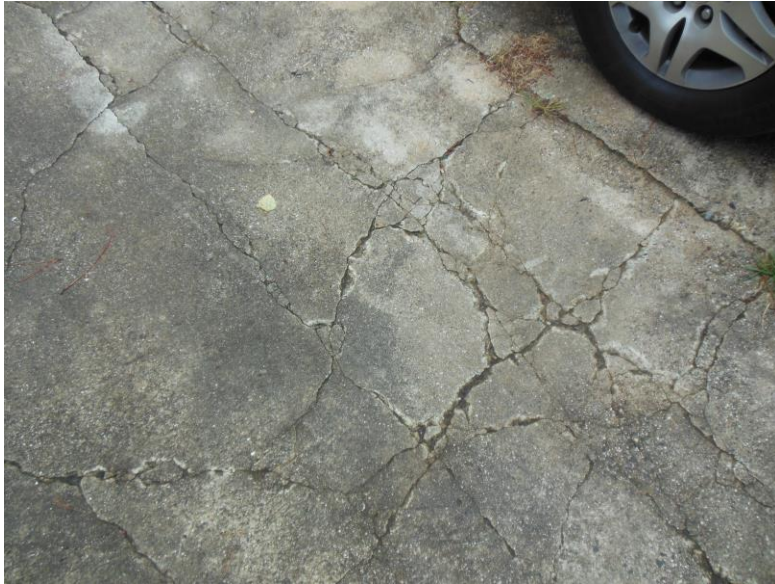
1. It was noted that the driveway is cracked and damaged.

An appropriate technician or contractor needs to further evaluate the above noted items and take the necessary corrective action.

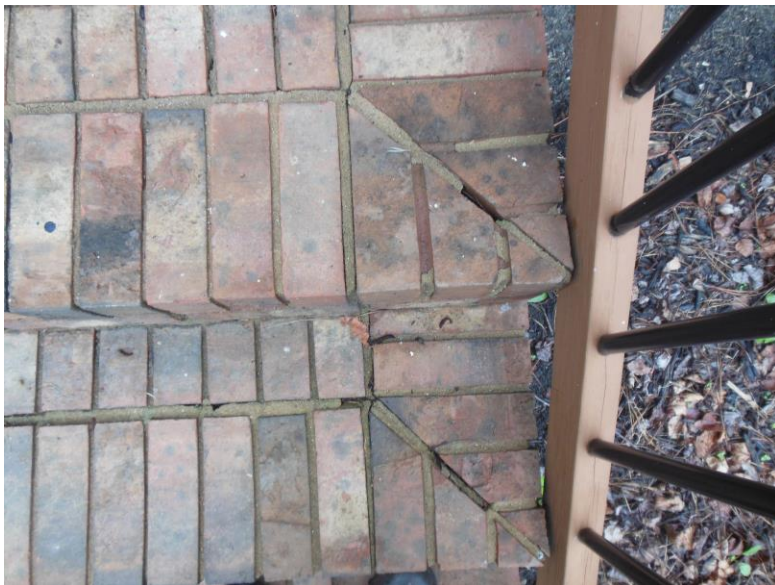
2. At the front steps small sections of the brickwork mortar are missing.

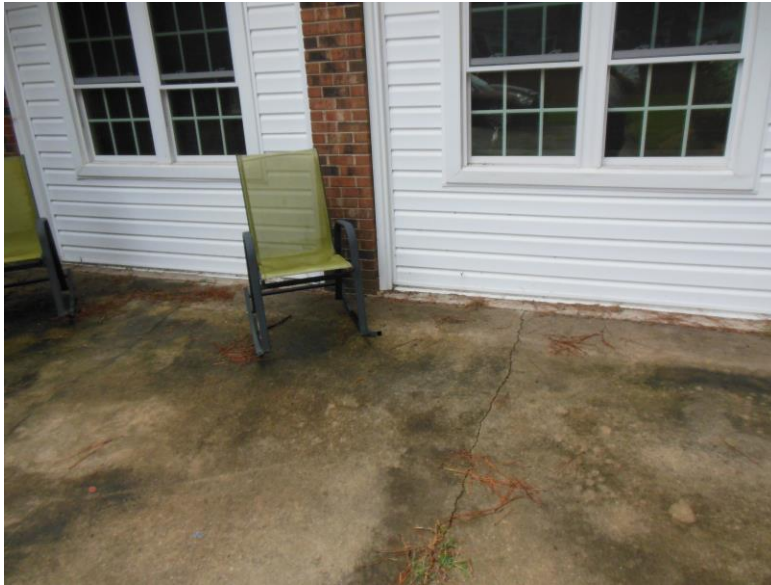
3. At the right rear exterior of the home it was noted that the garage has been converted to a family room and two bedrooms. It appears that the conversion has been completed without proper permits and inspections. It was noted that the level of the exterior of the wall with the vinyl siding is the same as the level of the interior floor which may allow water to seep under the wall framing.

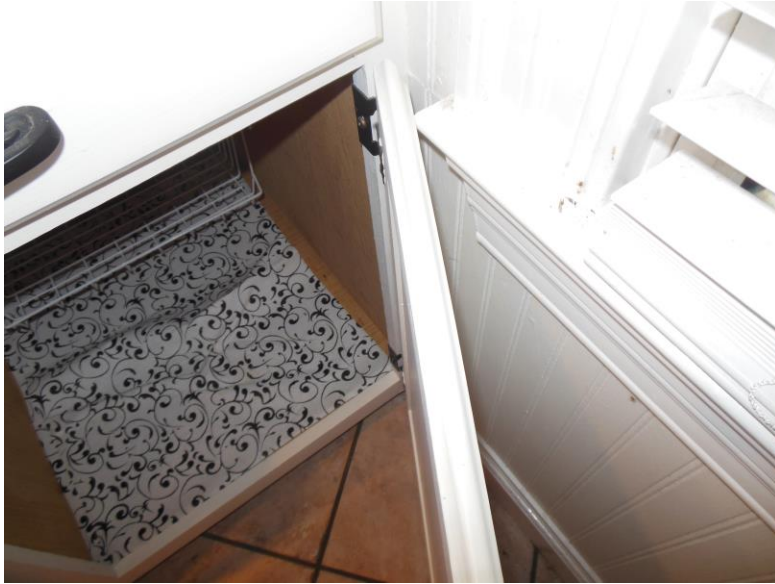
1. In the kitchen the cabinet doors near the window it the window sill.

An appropriate technician or contractor needs to further evaluate the above noted items and take the necessary corrective action.
