RON HOUGH
JOE MATTHEWS TERRY MURPHY
Inspecting Your Homes Since 1985

DATE: September 1, 2017

PROPERTY ADDRESS: 6625 Bobwhite Lane Browns Summit

SUMMARY/AREAS REQUIRING FURTHER EVALUATION

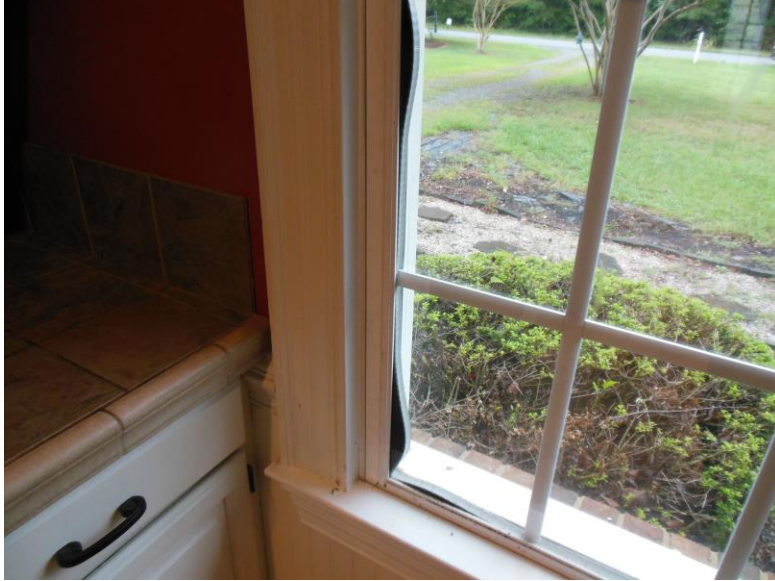
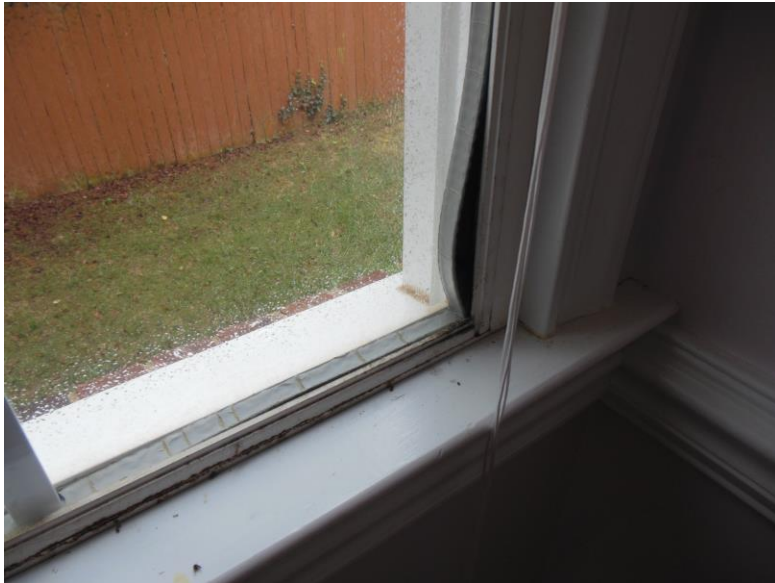
2. It was noted that the material between the panes of glass are deformed in the kitchen, in the left front bedroom, in the right front bedroom, in the master bedroom, and in the living room.

An appropriate technician or contractor needs to further evaluate the above noted items and take the necessary corrective action.

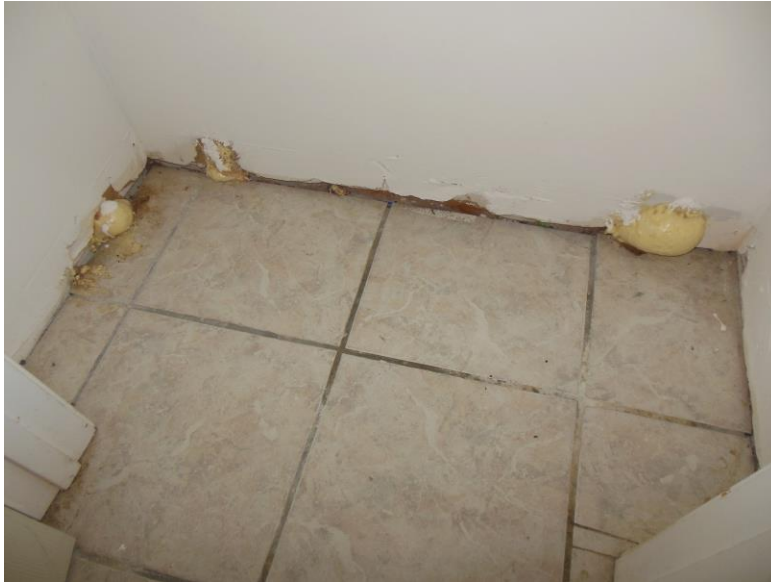
3. In the laundry room the floor trim is missing.

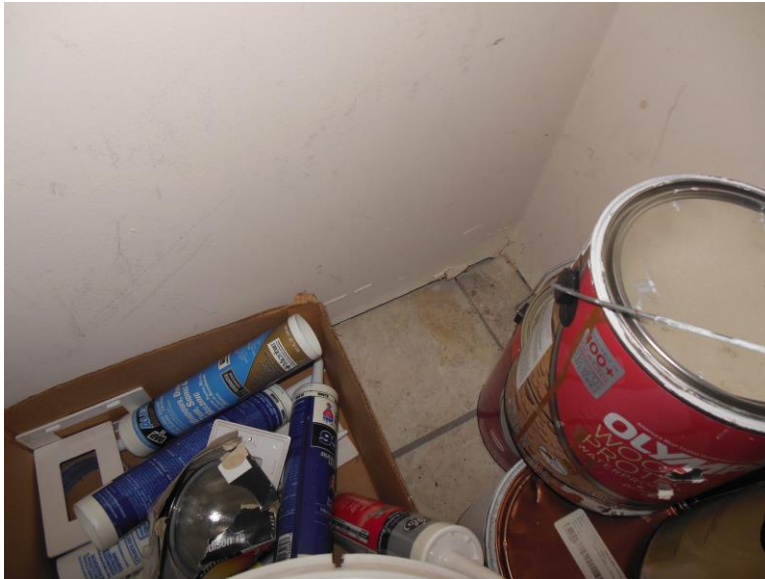
4. In the foyer closet the floor trim is missing.

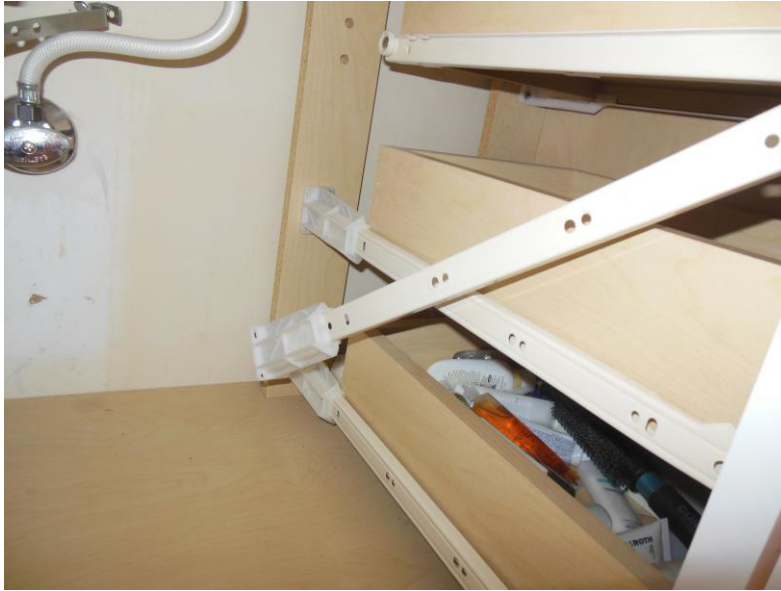
5. In the master bathroom the cabinet drawer slide is loose.

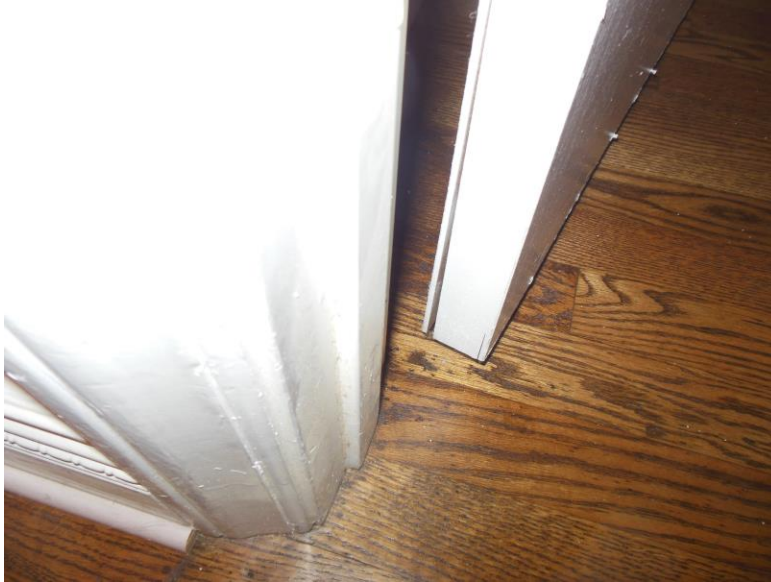
8. The left front bedroom entry door is damaged at the lower section of the door.
